# Gas processing plant reduces daily hot valve problem with innovative Inlet Integrity Program

## CASE STUDY

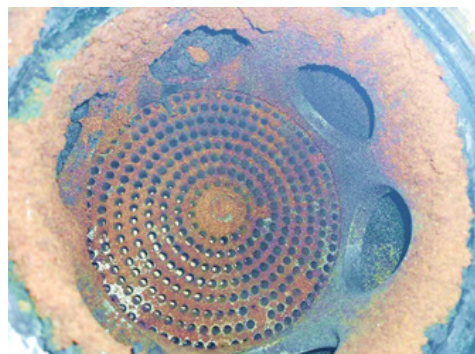
**FIGURE 1:** A typical compressor valve with fouling.

Figure 1 is a typical valve from the compressors with the fouling that would build up each week. This quickly became the biggest issue on the plant manager's mind.

The plant manager asked Nalco Water to help find a solution to this ongoing issue. The first step was to identify the chemical composition of the deposits. Samples were sent to the Nalco Water Analytical Lab for analysis, and it found that the deposit mainly consisted of salt<sup>1</sup>.

<sup>1</sup> Three samples were analyzed, which should an average of 74% NaCl in the deposits.

Nalco Water recommended feeding EC3699A, a compressor antifoulant that is part of the Inlet Integrity Program. This product is engineered to help remove more solids and dissolved salts

The EC3699A<sup>2</sup> was fed into the pipeline a few feet in front of the inlet separator using an atomizer to ensure proper distribution into the gas stream. Samples of the blowdown water were taken and analyzed for salt content and the plant monitored the compressors to see if there was any change in the maintenance frequency of the compressors.

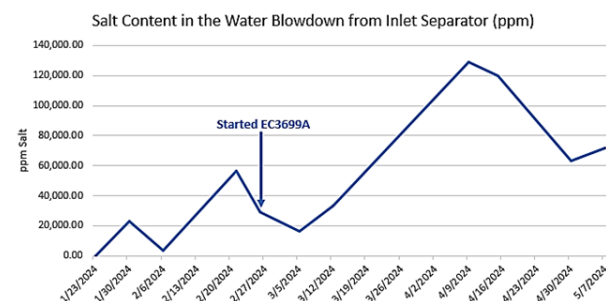
The blowdown samples showed a large salt increase in the water, see Figure 2. The average salt content in the water increased almost 250% from the pretrial samples. This data was a leading indicator that the product was removing the foulant in the inlet separator, preventing it from traveling to the compressors. However, the main criteria of the trial was to see an increase in the period between successive down times and a reduction in the frequency of compressor maintenance.

**FIGURE 2:** Blowdown samples.

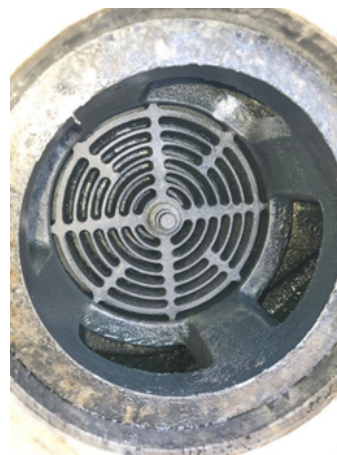
Compressor #7 was chosen as a basis for the trial. Two weeks into the trial, the compressors were showing no signs of issues. The plant manager decided to open up Compressor #7 to see if there was any build up. Figure 3 is the Compressor #7 valve at the time of opening. According to the plant manager, he had never seen a valve this clean after more than three days of use.

**FIGURE 3:** Compressor #7 valve at the time of opening.

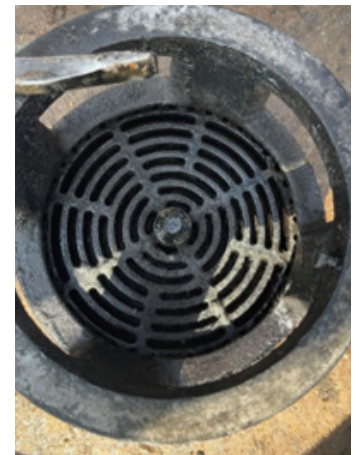
The trial continued without any issues from Compressor #7 or the other compressors for the next 8 weeks. Eventually, the compressor was opened due to a mechanical failure unrelated to the fouling. Figure 4 shows the Compressor #7 valve after ten weeks of chemical feed.

**FIGURE 4:** Compressor #7 valve after ten weeks of chemical feed.
