# 3D TRASAR™ Technology for Dilution Steam Systems Reveals Significant Swings in Quench Tower Process pH

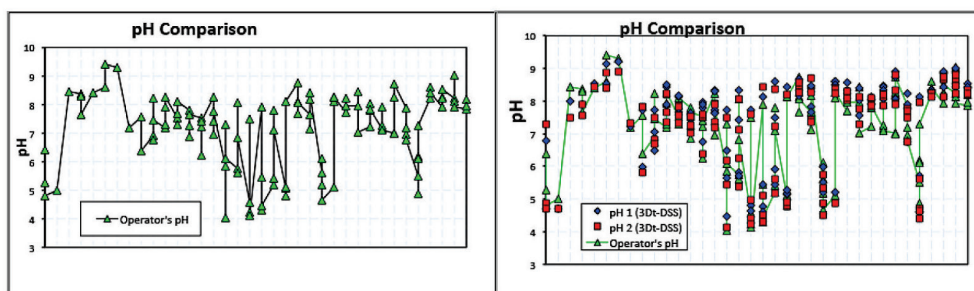
FIGURE 1: BASELINE pH - READINGS REPRESENT THE PH OF BOTH DEVICES DURING THE SAME TIMESTAMP

After calibrating the handheld and surveying twice a shift for six weeks, the results were plotted against the 3DT-DSS pH, shown in figure 1.

The 3D TRASAR unit was not only very accurate against the handheld, it delivered results greater than 90% success criteria.

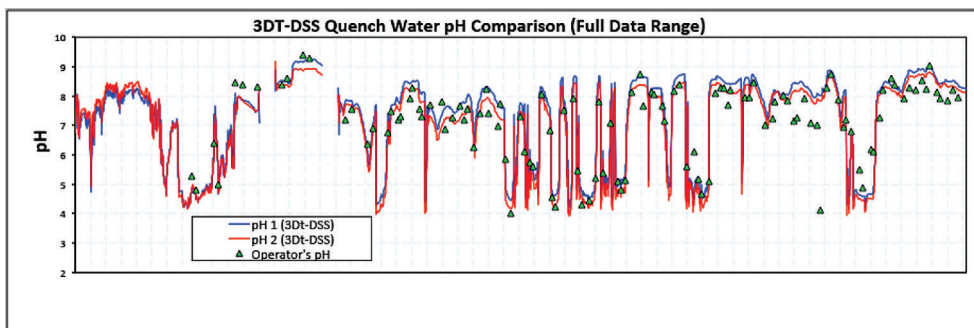
FIGURE 2: FULL pH DATASET PLOTTED WITH REAL-TIME 3DT-DSS RESULTS WITH MULTIPLE PH SWINGS

Further analysis was performed to understand what data the online measurement captured that the manual method might have missed (Figure 2).

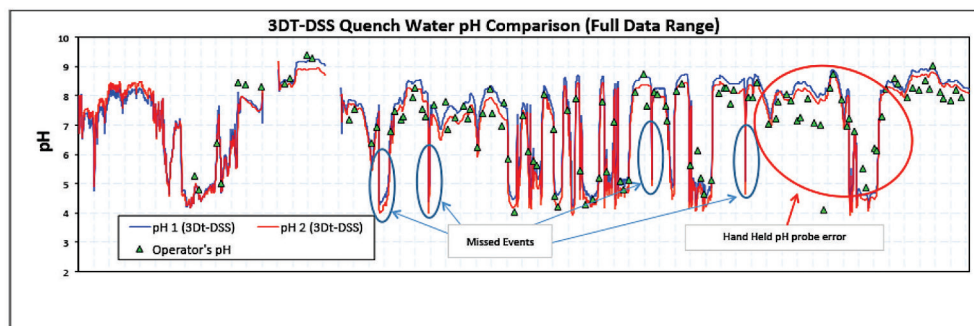
FIGURE 3: SIGNIFICANT pH EVENTS MISSED BY HANDHELD AND FAILED EQUIPMENT

Looking at the full online 3DT-DSS results, there were multiple periods where the pH dipped in between measurements which would have gone unnoticed had it not been for the 3D TRASAR unit. Figure 3 not only highlights these missed pH excursions, but also identified bias error in the handheld itself. This bias was discovered by the 3DT-DSS system because of the units redundant probes. Only after seeing both TRASAR pH readings consistently tracking similar values and the handheld readings diverging from the TRASAR's output(s), was the hand-held was recalibrated.

These pH excursions expose the unit to potential emulsions, foaming, corrosion, and accelerated fouling. After reviewing with operations personnel, it was identified that the error in the hand-held was due to contamination in the probe. Again, this would not have been captured without the dual pH probes to validate the problem and launch an investigation into the error.
