# Ecolab® Heat Exchanger IQ™ Provides Unique Insight Into Cooling Water Treatment and Heat Exchanger Performance

## CASE STUDY

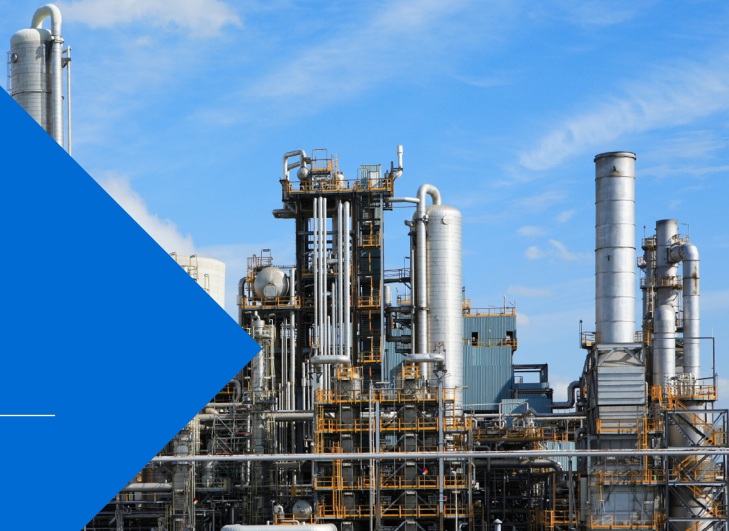
The patented Sentinel™ Test Heat Exchanger, part of the Heat Exchanger IQ program, eliminates this inherent design weakness by using a liquid-to-liquid interface that provides uniform heat transfer to the tube surfaces and, therefore, much more realistic results.

Sentinel has two annular exchangers consisting of a ½" OD metal tube inserted in a 1" clear polycarbonate shell. The tubes are designed to match existing metallurgy. The ½" exchanger tubes are pre-weighed before exposure to the cooling water. Cooling water flows through the exchanger on the shell side (outside the ½" tube), and process water flows inside the ½" tube. Sentinel can model skin temperatures from 80°F to 190°F, and velocities from 1 to 8 fps. In this evaluation, cooling water velocities were set and maintained throughout the exposure period in both exchangers at 4.0-4.5 fps. Two different skin temperatures were modeled. Exchanger #1 was set at the design skin temperature of the process exchanger bundle at 115°F, and Exchanger #2 was set at 125°F.

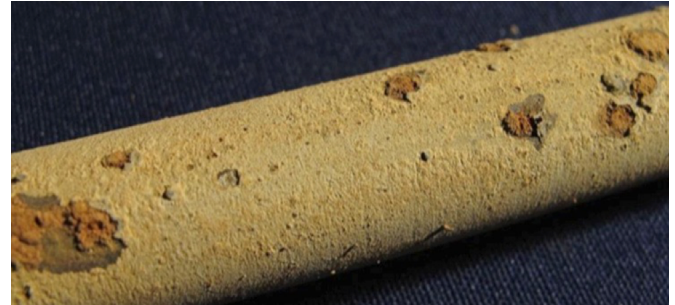
**FIGURE 1**

Photomicroscopy and deposit analysis conducted on both exchangers showed a buildup of mineral scale (Figure 1), primarily composed of iron phosphate, which resulted in under-deposit corrosion (Figure 2).

**Exchanger 1: Velocity: 4.0-4.5 fps; Skin Temperature: 115°F**

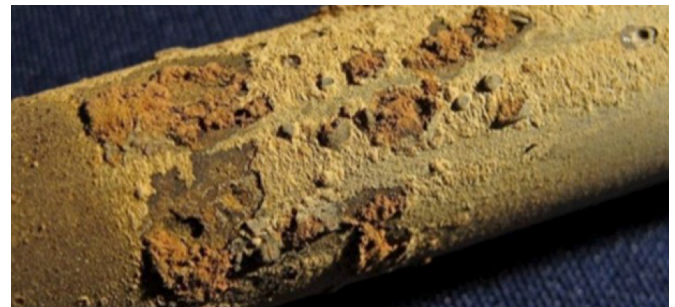
**FIGURE 1**

A thicker layer of iron phosphate scale (Figure 3) was found on Exchanger 2 that operated at 10°F higher skin temperature. The scale surface is interrupted by iron tubercles which, once removed, revealed deep pits (Figure 4). In contrast, the coupon results from 46-day exposure period contained few localized corrosion results, and no reported pitting to the extent observed on the exchanger tubes.

**Exchanger 2: Velocity: 4.0-4.5 fps; Skin Temperature: 125°F**
