## Louisiana Power Plant Uses Innovative Nalco Water Technology to Detect Fouling and Maximize Revenue

At this 585 MW coal-fired power plant, changes to their water source threatened to impact plant operations. To address the challenge, the plant engineering staff used an innovative Nalco Water deposit sensing technology to provide a heads-up when scaling risks increased.

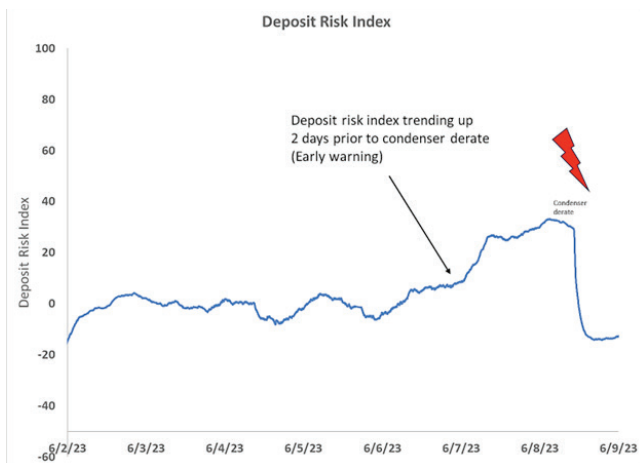
Figure 1. Plot showing deposit risk index at the power plant from the deposit sensor (higher the deposit risk index, higher the deposition stress). Deposit risk index trends up on 06/02/23 and 06/07/23 indicating increase in deposition stress during this period.

Shortly after the deposit sensor was installed, the sensor reported a performance decline. Plant personnel attributed it to suspended solids released into the bulk water by a recent start-up. The sensor was cleaned and returned to service. The sensors reported the rapid deposition event again. (Figure 1).

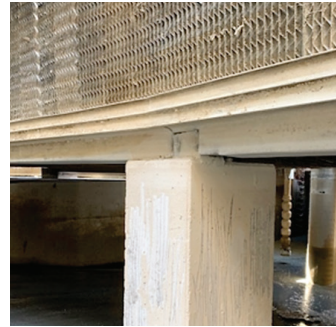
Image 2. Due to operational issues, the plant was unable to respond to the early deposit stress warnings. As a result, an iron-silica deposition event occurred which fouled the cooling tower and condenser and forced shutdown for remediation.

Further investigation revealed several operational and chemical changes as the causes of the deposition. The start-up played a role by increasing the concentration of suspended solids, but the higher iron and silica concentrations in the new make-up water source, combined with poor control of cooling tower cycles of concentration and loss of dispersant feed all combined to cause

the deposition event (Image 2). The data collected, transmitted and analyzed by the Nalco Water team helped the plant engineering staff make good decisions about how this event happened and what could be done to prevent its recurrence. This event was severe enough to cause a plant derate and a chemical cleaning of the condenser during a time of peak power demand. The estimated lost revenue was over \$3 million. Subsequent deposit analysis confirmed what the Nalco Water technology had predicted: an iron-silica scale caused by elevated levels of contaminants associated with the recent startup and the new well-water source (Figure 2). The plant incurred a cleaning cost of \$41,000 to bring the condenser back to peak efficiency.

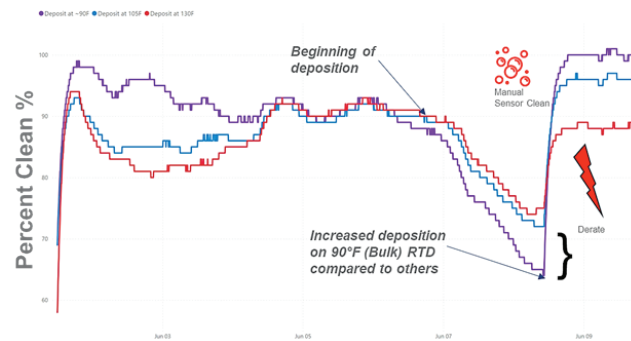
Figure 2. Plot showing raw RTD data with three distinct temperatures (Bulk (90°F), medium (105°F) and hot (130°F)); hot temperature RTD indicating skin temperature of the condenser. Bulk temperature displays the highest decrease in % clean indicating silica deposition (silica has higher propensity to deposit at lower temperatures).
