# Louisiana chemical plant minimizes production losses using patented deposit sensor technology to identify and proactively address biofilm deposition

## CASE STUDY

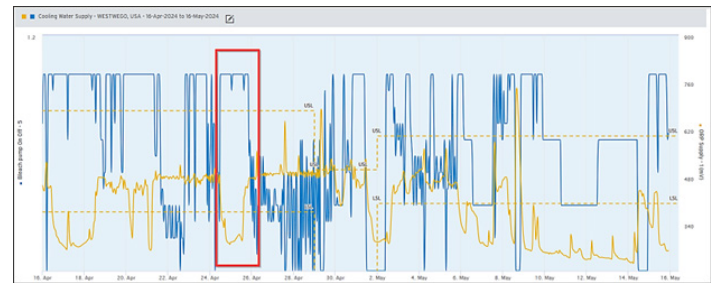
**FIGURE 4:** On 24-25 April, oxidation-reduction potential (ORP) declined, but the bleach pump relay indicated the pump was running. However, the bleach pump had failed. Once the pump was repaired, ORP increased and the deposit risk index declined, indicating a clean-up of the biofilm.

Premium Plus detected a second event which the sensor identified as biofilm deposition (figure 3). Nalco Water's EGIC team investigated further and identified the root cause to be a discrepancy in bleach feed (figure 4). Nalco Water representatives worked closely with the customer to implement bleach feed changes to return the system to normal.
