Inlet Integrity Program helps a natural gas plant reduce compressor maintenance by 56% and save \$630K annually

CASE STUDY

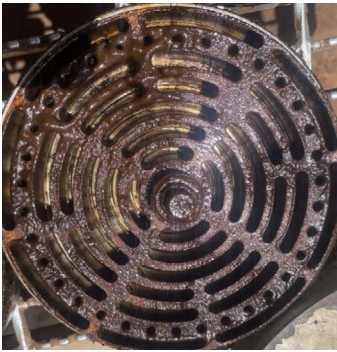
low-pressure compressor valves. The suction valves on their compressors were getting fouled with a combination of salt, iron sulfide and other foulants that led to overheating of the valves, also known as "hot valves". In one month, the plant had 180 hot valves across their four compressors. This was causing high maintenance costs, requiring the company to rebalance the network to send gas to other plants while their team worked on replacing the valves.

Figure 1: Compressor valve at program start.

Nalco Water was asked to investigate the situation to provide a recommendation. The Nalco Water personnel worked with the local team to audit the system and get deposit samples for analysis. After confirming what was depositing on the compressor valves, it was recommended to implement a three-product approach.

The first two products are part of the Nalco Water Inlet Integrity Program. An iron sulfide inhibitor was fed to help remove that portion of the foulant. This product was fed upstream of the plant.

The second product was a general antifoulant designed to help pull materials into the aqueous phase of the inlet separator,

so they are blown down with the water. This was fed to help remove salt in the inlet separator and was fed directly before the vessel.

The second part of the program was a compressor antifoulant to minimize solids that make it past the inlet separator from depositing on the compressor, which was fed directly before the compressor.

In addition to the three products, Nalco Water recommended adding a water wash injection directly before the inlet separator to help with the separation of solids from the gas. This program was selected because it had success with a similar issue at their other plant.

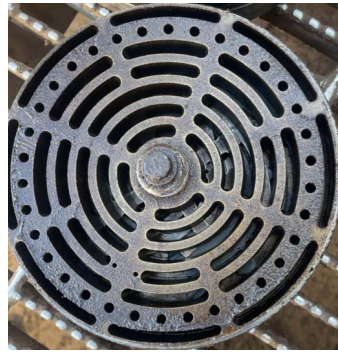
The plant saw immediate results with the recommended program. The hot valves on the compressors started to slow down. During the first two months, the program helped reduce the number of hot valves that occurred by 57. During this time, the local team continued to meet with the customer and optimize the feed rates. Months three and four reduced the number of hot valves by 121 and 102, respectively, compared to before the program started.

Figure 2: Compressor valve after Inlet Integrity Program implementation.
