# Scale Formation Control on Lead Washers

## ABSTRACT

At Rio Tinto Yarwun alumina refinery many improvements have been implemented in order to minimise the scale formation in the lead Washers. One of these initiatives is the Nalco Water ScaleGuard program. This paper describes the method applied for the plant trial and its results.

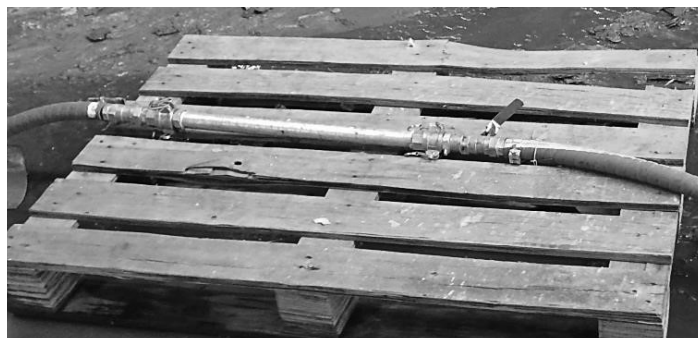
- Deposition on steel coupons suspended in the clear liquor zone of one of the lead Washers during each test
- Deposition inside a 500mm piece of 25mm diameter steel pipe through which the overflow of that vessel was continuously flowing at a constant rate during each test.

*Figure 1. Side stream overflow pipe arrangement*

In addition to scale measurement via coupons, the performance of ScaleGuard was measured in a side stream of the washer overflow. For this, a continuous flow of 40L/min was diverted and passed through a 500mm long section of 25mm diameter steel pipe. This flow was

checked and regulated daily to ensure the velocities in the pipe for each test were the same.

The target velocity was set to being similar to that in the washer overflow line during normal operation.

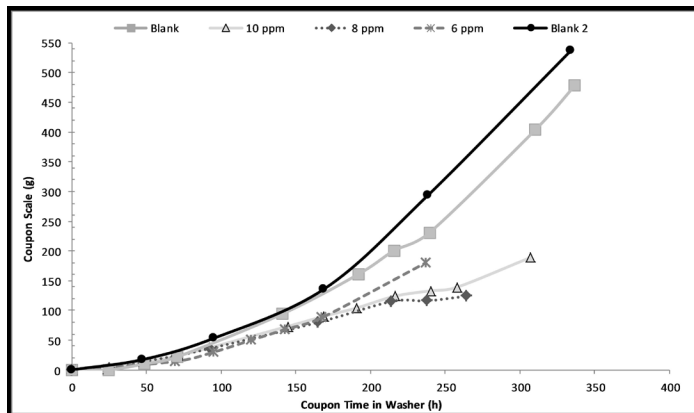
Figure 2 outlines the mass of scale vs time in the lead Washer coupons at the various trial conditions.

Figure 2. Coupon Scale Growth vs Time

While the impact of the ScaleGuard dosing on the coupons results are evident, it should be noted that the location of the coupon inside the tank was limited to existing hatches on the tank roof. No work was conducted to determine if dosing location relative to coupon position was optimum to give the best results from scale coupons.

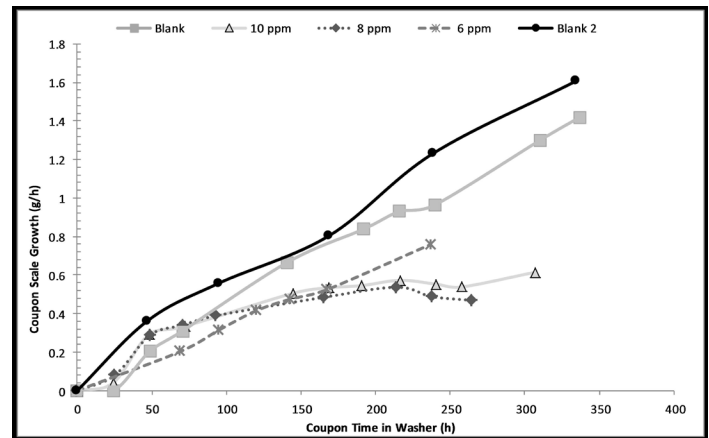
The rate at which scale grew on the various coupons is illustrated in Figure 3. Interestingly the growth rate on the untreated coupons continued over time, while there is a plateau observed in both the 10ppm and 8ppm trial data at around 0.55 - 0.6 g/h. This suggests the benefit of ScaleGuard treatment for these tests would increase with time and the success criteria met, if the trials continued on trend for a longer period.

Figure 3. Coupon Scale Growth Rates

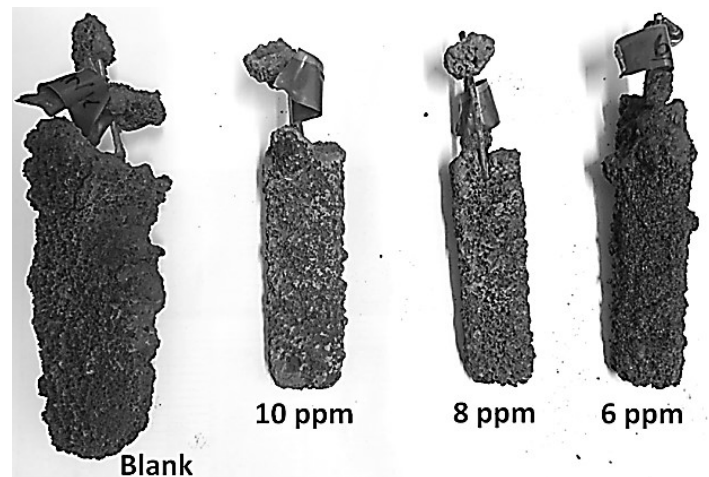
Figure 4 shows a photograph of the scale coupons following each trial phase. Although there are some differences in the trial phase durations, the contrast between treated and untreated is significant.

Figure 4. Scale coupons following each trial

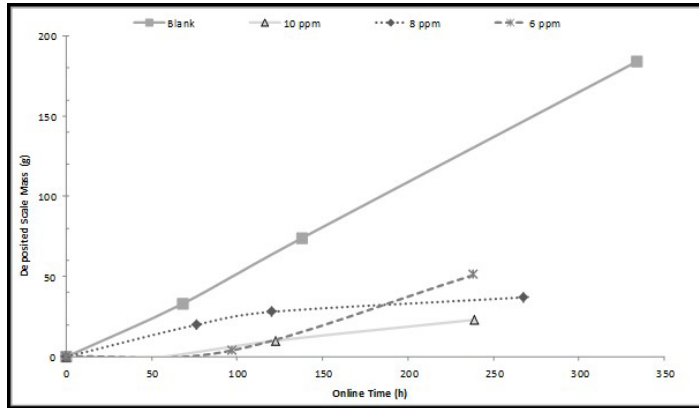
The scale deposition was measured through changes in the mass of the pipe at various stages through each trial phase. The results are shown in Figure 5 below.

Figure 5. Overflow pipe scale growth

Figure 5 outlines the reduction in scale deposition on the overflow pipes compared with the untreated blank.

Interestingly, the scaling rate change (gradient shift) in the trends in Figure 5 above for both the 8 and 6 ppm trials coincide with the interruption in chemical dosing in each phase outlined in section 3.1. In each case, the interruption coincided with an increase in measured deposition. That is before (and just after) the first measurement in the 8ppm trial and for 21 h in between the second and last measurement in the 6ppm trial.

Given the infrequent measurements of the pipe mass during each trial it is difficult to draw clear conclusions as to what influence the dosing interruptions had on total scale deposition.

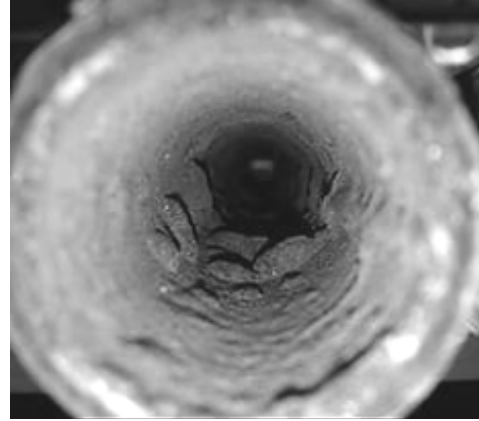
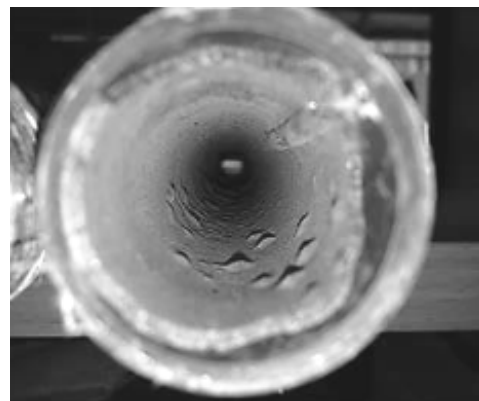
Figures 6a to 9b show a view looking inside each pipe (from both ends). This provides some insight as to the differing appearance and amount of deposition.

Figure 6a. Pipe - Blank - Inlet view

Figure 6b. Pipe - Blank - Outlet view

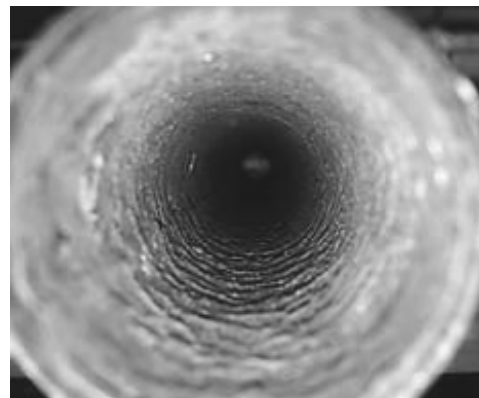
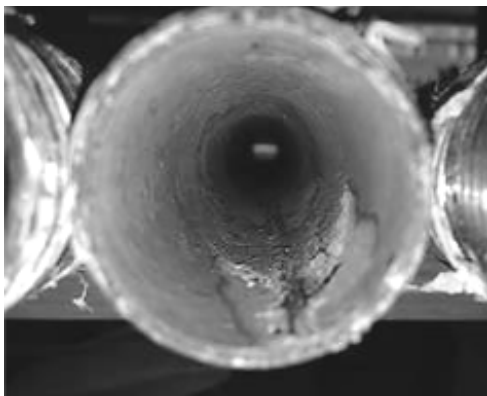
Figure 7a. Pipe - 10 ppm - Inlet view

Figure 7b. Pipe - 10 ppm - Outlet view

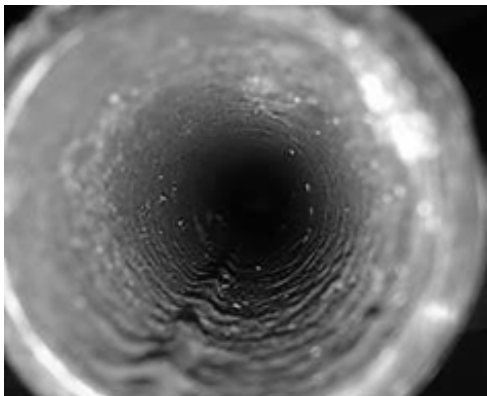
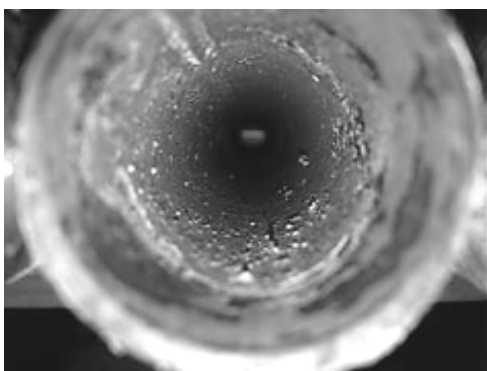
Figure 8a. Pipe - 8 ppm - Inlet view

Figure 8b. Pipe - 8 ppm - Outlet view

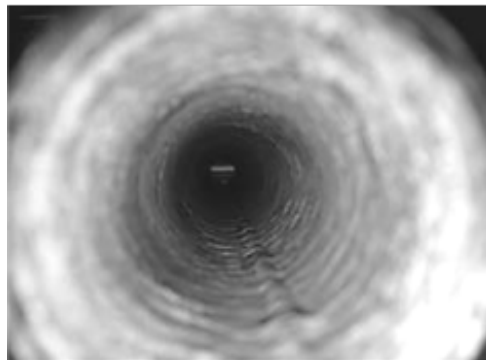
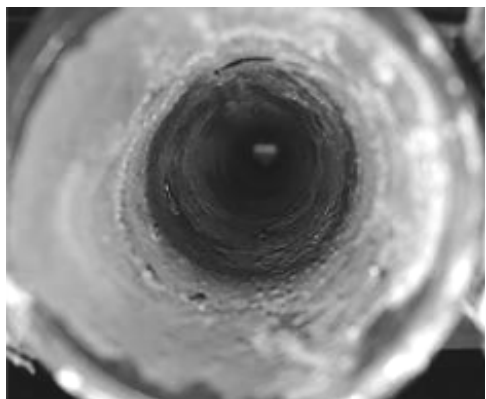
Figure 9a. Pipe - 6 ppm - Inlet view

Figure 9b. Pipe - 6 ppm - Outlet view
