# OreBind™ Technology brings Tailing Storage Facility footprint back into use 9 years early at a savings of \$4.2 million

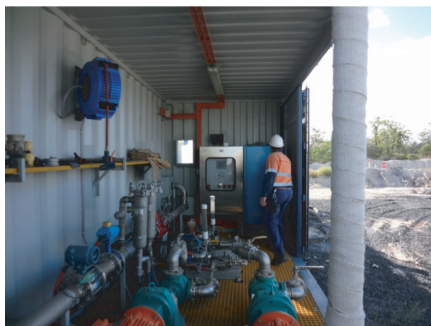
*OreBind control system*

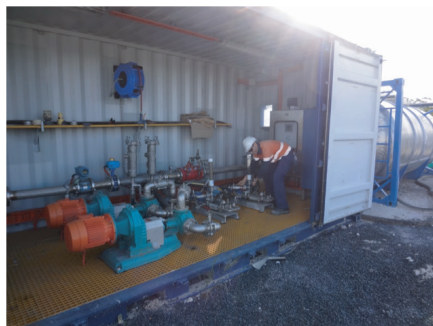
*OreBind quick inversion and dosing equipment*

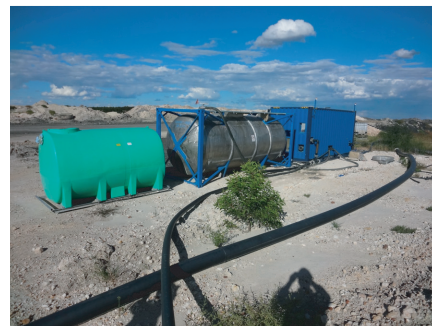
*OreBind Storage, Make-up, dosing and control equipment - compact*
