# Ecolab® CondenserIQ™ and Macrofouling program saves utility \$3MM per year

CASE STUDY - POWER

CH-2027

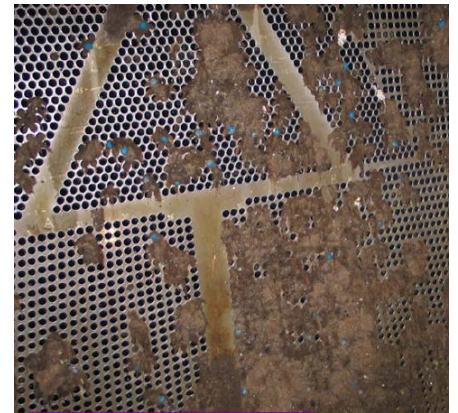
certain mass on the walls of the intake tunnels and cooling system piping, it sloughs off in matts that foul the inlet tube sheets of the condenser, as shown in this photo. Inlet tube sheet fouling leads to higher temperature rise and backpressure on the condenser. The result is a loss of unit operating efficiency (increased heat rate) and a loss of generating capacity. Approximately 15 mechanical cleanings of the condenser water boxes were performed each year. In addition to manpower costs, each cleaning requires the unit be “downpowered” with an associated loss in generating revenue.

Macrofouling has negatively impacted the performance of this power plant for most of its nearly 40 year operating life. The hydroid *Garveia Franciscana* grows throughout the twelve cooling water intake tunnels and circulating water piping. Research studies conducted on the Chesapeake Bay have shown conditions that favor the growth of this (invasive, non-native) hydroid species include water temperatures above 55° F and a flow velocity below 2 fps. As the hydroid growth progresses, it restricts the water flow through the circulating water piping. Once the growth of hydroids reaches a
