# APEX™ Technology Improves Paint Detackification Performance and Delivers Major Cost Reduction

CASE STUDY - AUTOMOTIVE

CH-2057E

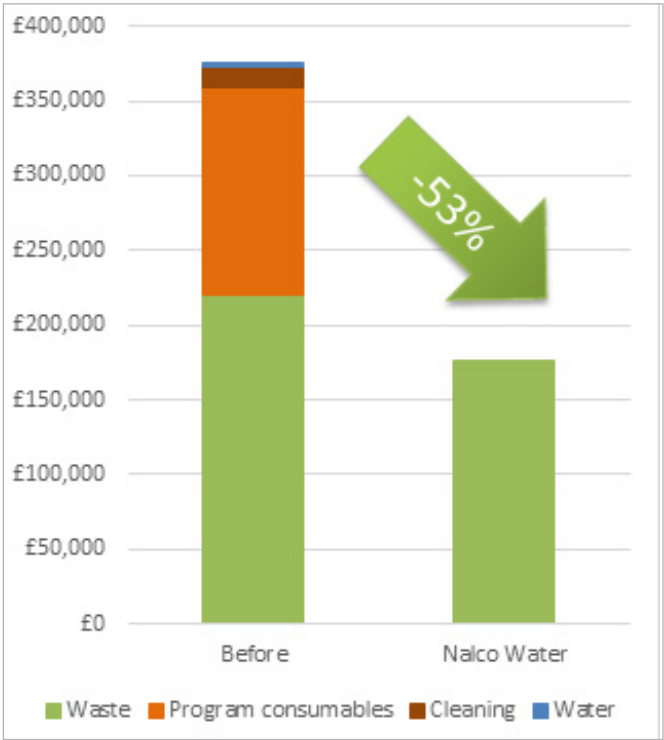
Graph 2: APEX Technology achieved 53% TCO reduction

- A significant reduction in chemical costs has been captured by the customer compared to those borne with the previous supplier after several years of apparent optimization. Savings are estimated at £140,000 per annum compared to the prior year before Nalco Water started.
