# Nalco Water's 3DT397 Technology Reduces Corrosion and Environmental Impact at Power Plant

CASE STUDY - POWER

CH-2103

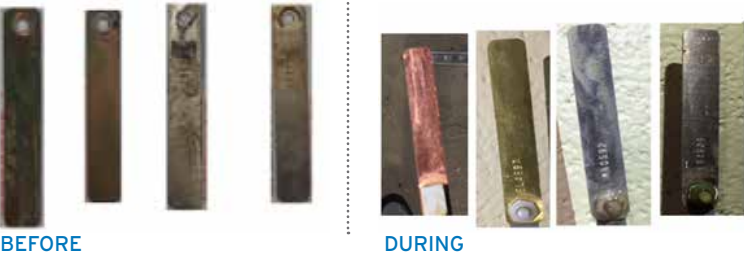
Table 1: Corrosion Coupons. Baseline (left) and Yukon (right)

Achieving good microbial control in this variable, challenging water required a high FRC. 3DT397 gave the plant the freedom to apply those levels of oxidant without impacting asset integrity, as shown in Table 1. Corrosion coupon results using Yukon were significantly better.

Brass corrosion dropped by 75% to 0.1 mpy, while Cu:Ni alloy corrosion dropped 80-90%. Copper concentrations in the discharge dropped 60%.
